Yarnfield and Cold Meece Parish Council Village Green Project Proposals

March 2025

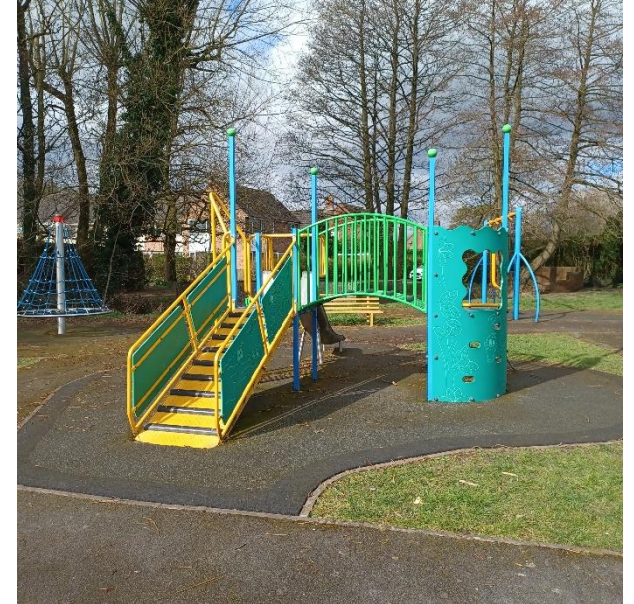
Multi Play

- Some minor repairs

- The play surface is lifting at the edges and creating trip points -Repair perimeter of surfacing to remove trip points
- There is moderate damage to the play surface – Repair
- A number of rope connector fixing(s) have worked loose. Secure all loose fixings

- Inspection report applying current standard to old piece of equipment
- Deterioration of the play surface will incur ongoing maintenance costs.

- Include repairs in future program

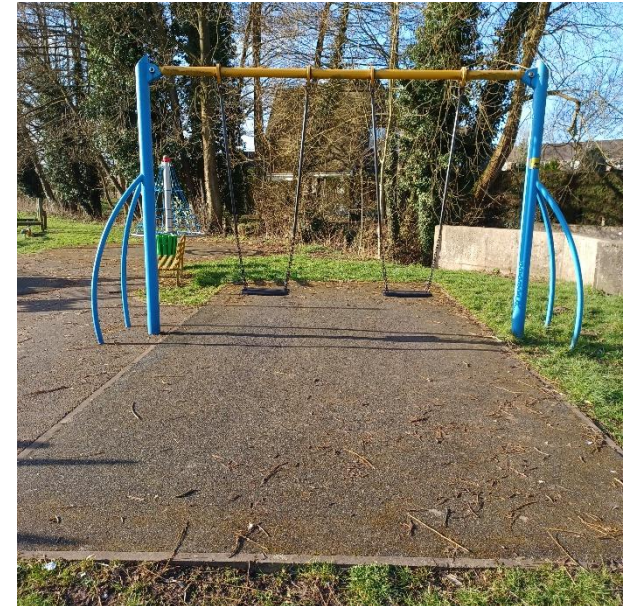
Flat Swing

- Original piece of equipment
- Monitoring of chains and moving parts required.

- The chain links are worn excessively and require renewing - replace worn chains
- The swing bar connecting lugs are showing signs of wear - monitor
- There is some wear to the shackles - monitor
- The bush / bushes is / are showing signs of wear – monitor
- The seat has minor damage or wear - monitor
- There are trip hazards at the edges of the surface – remove trip hazard

- Popular piece of equipment
- Deterioration in moving parts and chairs require regular monitoring
- Deterioration of bearings is causing nuisance noise affecting residents

- Tender to include price for full overhaul.

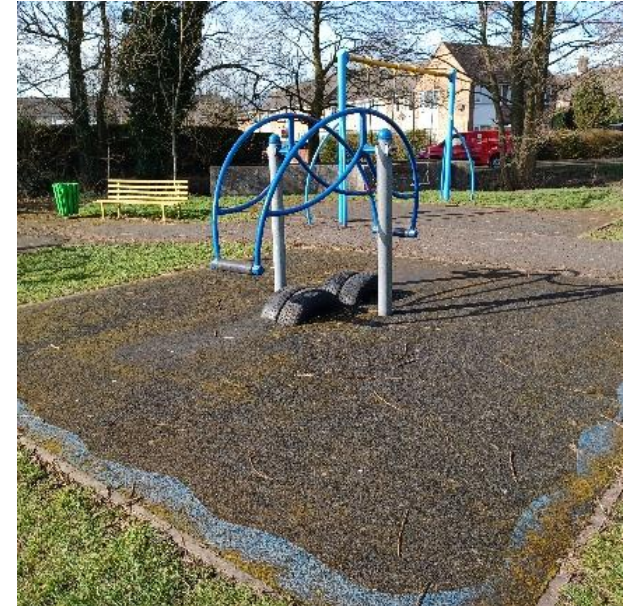
Stand on Rocker

- The two bearing need to be replaced at a cost of £500.
- Tyre bumpers need replacing .
- Some damage to the safety play surface.

- The damper tyres are damaged - Replace
- The paint is flaking off the metalwork - Rub down and repaint
- The pivot dampers are worn – Replace
- Replace all missing fixings on footrest

- Poor condition of the safety play surface has been repaired on at least two occasions and the surface over topped, which is why the surface stands 150mm about the original height.
- The stand on rocker needs to have over £500 spent on it to replace the worn bearings. In addition, the play surface and tyre bumpers are in a particularly poor condition.
- The replacement of this equipment with a new seesaw (details below) would be sensible as it would remove one of the older pieces of equipment, avoid the repair costs and deal with the deteriorating play surface at the same time.

- Remove to make space for new equipment

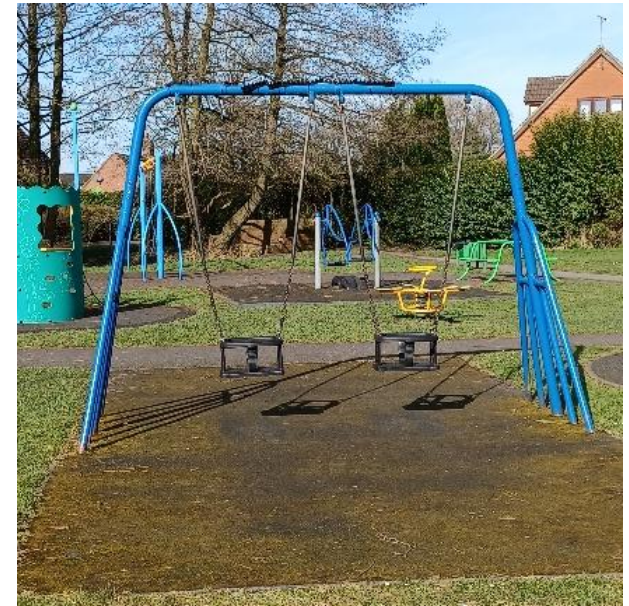
- The Cradle Swing is the oldest piece of play equipment
- Previous work to paint the equipment has deteriorated
- Safety play surface tends to flood during heavy rain

- There is some minor damage to the safety play surface - Monitor for any further deterioration and repair as required

- Equipment is very popular
- Play surface is 150mm lower than the surrounding land and the surface routinely floods during periods of heavy rain. The play surface is affected by algal growth.
- Poor play surface detracts from the appearance of the playground.
- Deterioration of the play surface will incur ongoing maintenance costs and ultimately will need to be replaced

- replace two bay cradle swing with a three-bay swing with one seat being specifically designed to be all inclusive

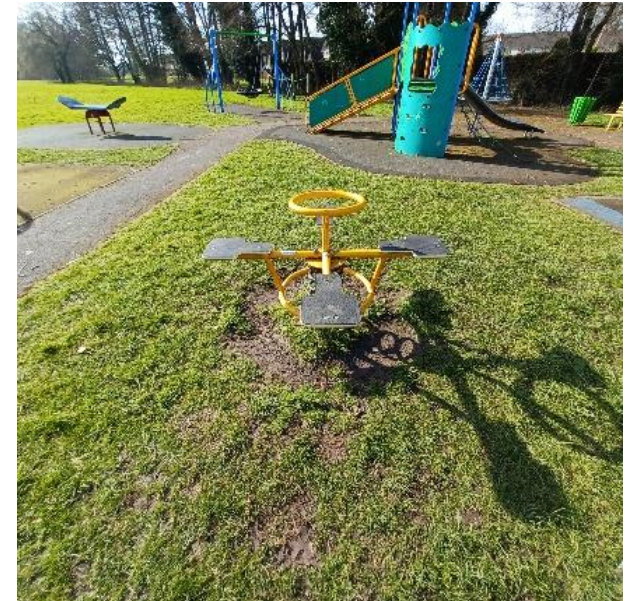
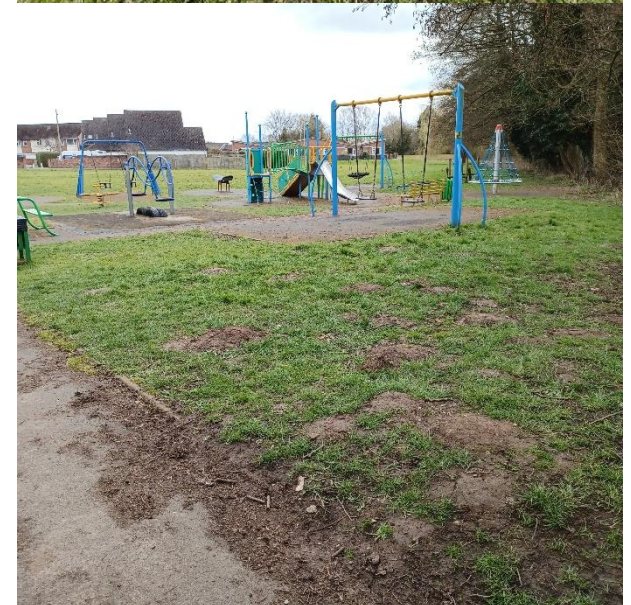
Four Way Springer

- Good condition
- Spring replaced in 2022

- The grass mats are silted up, the soil is compacted, and the area will become very slippery when the soil is wet. Reinststate as required

- The equipment is a popular piece of equipment.
- The lack of an all-weather play surface detracts from the appearance of the playground

- Move to a different location next to the swings to enable new equipment to be installed.
- New location to include safety play surface.

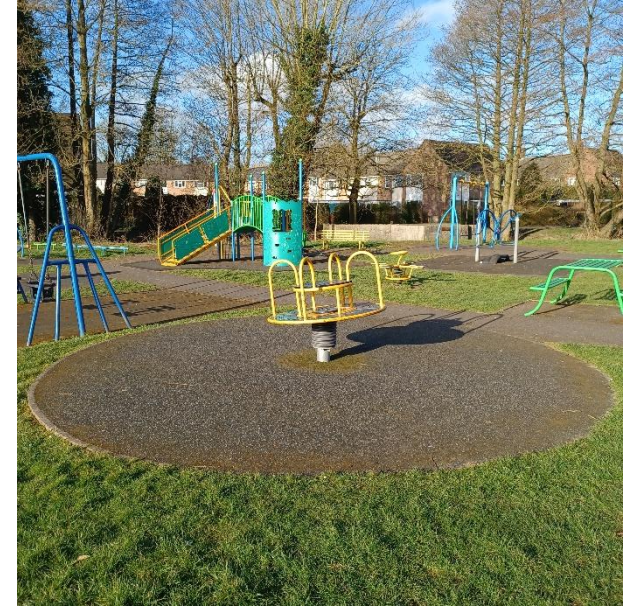
Roundabout

- Good condition

- There are trip hazards at the edges of the surface - Remove

- Popular piece of equipment
- Deterioration of the play surface will incur ongoing maintenance costs

- No action

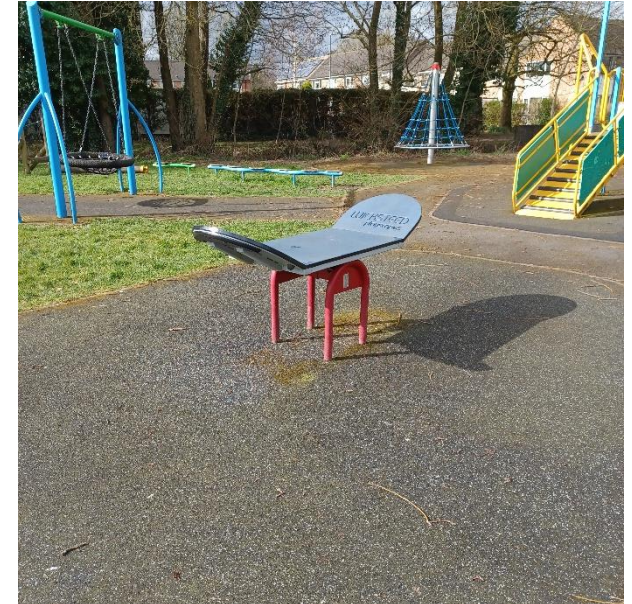
Surf Board

- Good condition

- There are trip hazards at the edges of the surface - Remove
- trip hazard

- Least used piece of equipment
- Has limited value. Only been seen being used as a seat by children

- Remove or relocate to provide space for three bay inclusive cradle swing

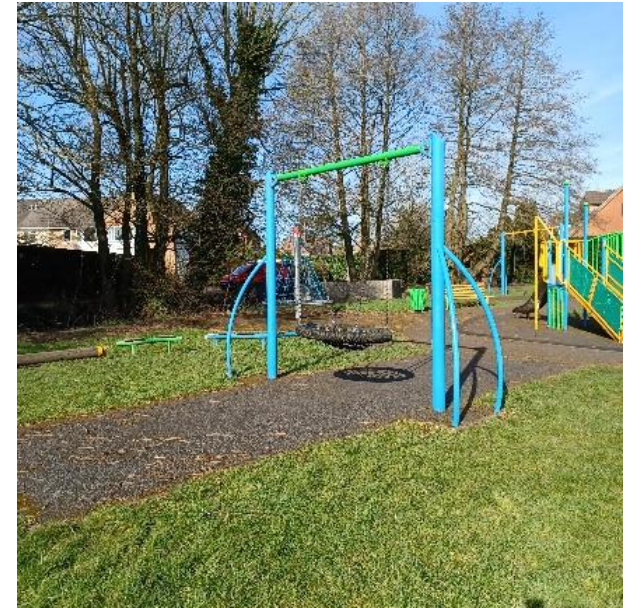
Basket Swing

- Good condition
- Chains and bushes replaced in 2024

- The seat is suspended unevenly - Adjust suspension so the seat is level at rest
- There are trip hazards at the edges of the surface – Remove trip hazard

- There is some notable evidence of chain wear - Monitor for any further deterioration and replace when 40% worn
- The bushes are showing signs of wear – Monitor for any further deterioration and replace as required

No action required – see note about trip hazard.

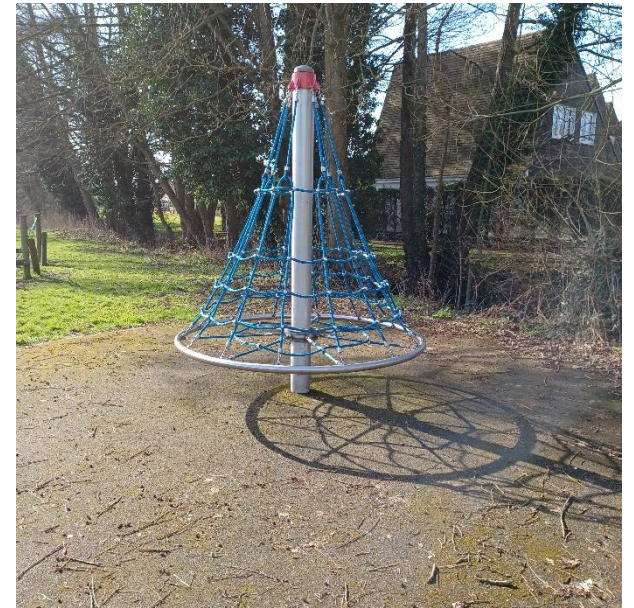
Cone Climber

- Good condition

- A number of fixing(s) have worked loose - Secure all loose fixings
- There are trip hazards at the edges of the surface – Remove trip hazard

- This is a popular piece of equipment.
- Only routine maintenance work required.

- No action required – see note about trip hazard.
- Undertake maintenance work.

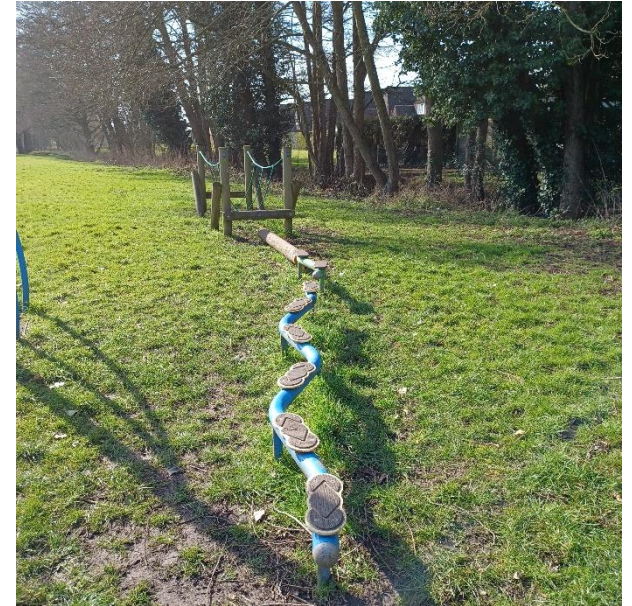
Activity Trail

- Wooden construction is resulting in deterioration of the equipment.

- The item has been damaged - Monitor for any further deterioration and replace as required
- The bearing is worn / damaged and the item is not operating correctly - Repair / replace
- The tree canopy overhangs the equipment and is less than 2.0m away - Lift tree canopy
- There is algae or moss on the surface of the equipment. Clean and treat appropriately
- There is some strimmer / machinery damage apparent on the posts,
- The surface has eroded in some areas and may be slippery in wet conditions - Reinstate the surface

- Inspection report identifies age related repairs

- Routine maintenance to address over hanging branches.
- Add repairs to future repair program
- Tender to include options to extend activity trail

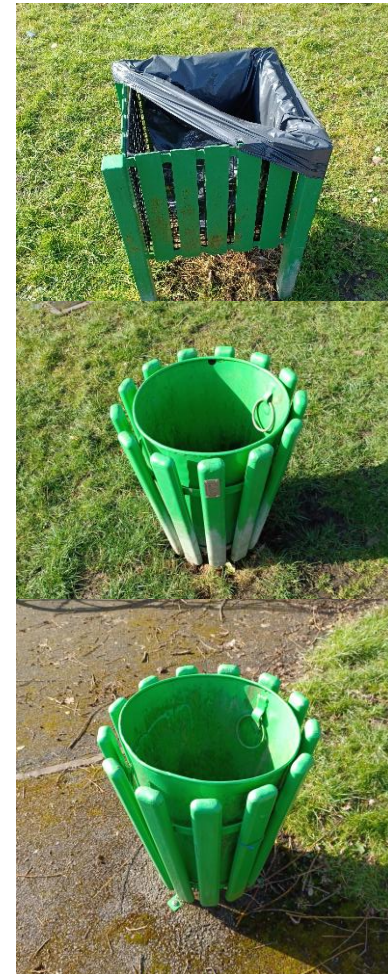
Litter Bins

- Open topped, metal liners not secured to frame, badly corroded.
- Location next to seating area not ideal

- metal liners for round bins not secured to frame

- The three bins detract from the appearance of the playground and their design is no longer appropriate.
- Siting of the bins could be moved away from the seating and benches.

- Replace with two new bins

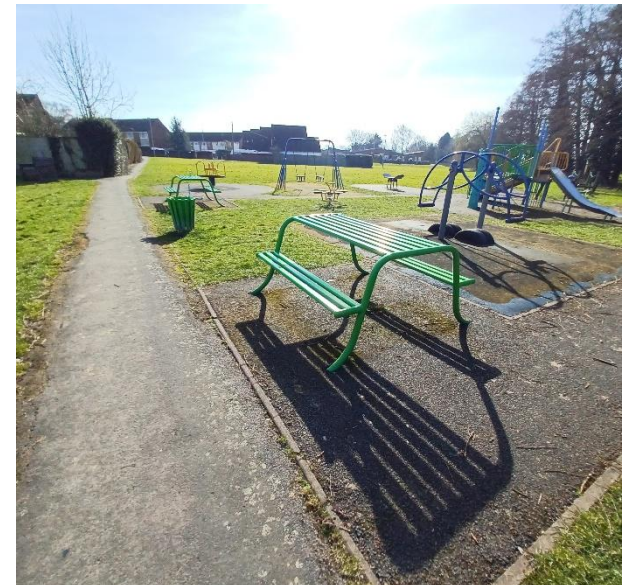
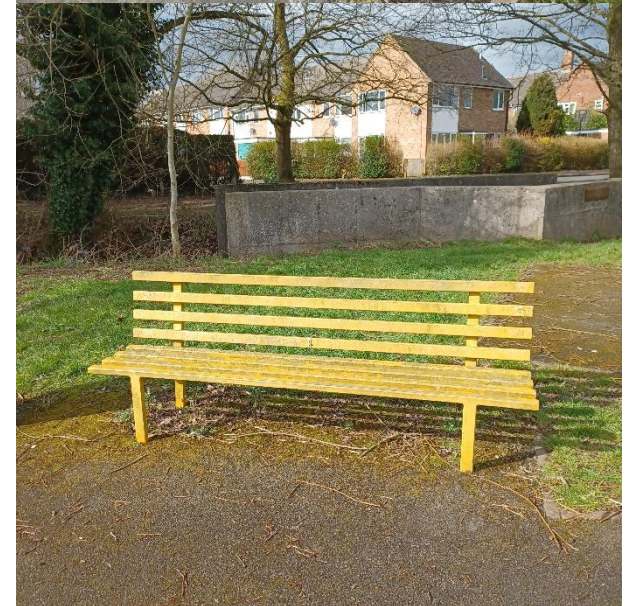
Seating and benches

- 2 benches

- The bitumen surface is worn or damaged - Repair the bitumen to provide a uniform surface
- There are trip hazards present - Remove trip hazard
- The paint is flaking off the metalwork - Rub down and repaint

- During busy periods more seating is needed to enhance the experience of parents and guardians.

- Monitor condition of the benches and seats
- Consider replacing the old metal seat
- Add 1 or 2 new plastic benches on the southern edge of the playground

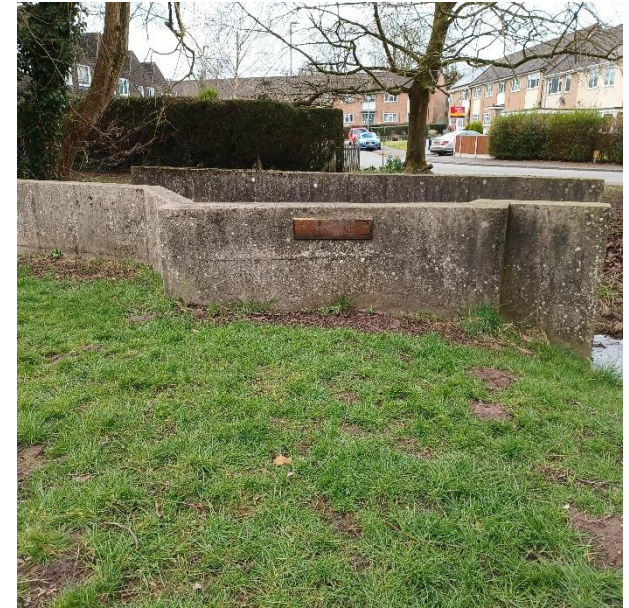
Signage

- Damaged

- It is recommended that signage, with information including the site address, contact information for maintenance issues and emergency contact details are provided for the facility -Provide in accordance with the recommendations

- Sign damaged in 2024 and removed

- Provide new sign with appropriate contact information
